# A SURVEY OF SERIOUS AIRCRAFT ACCIDENTS INVOLVING FATIGUE FRACTURE

## VOL. 1 FIXED-WING AIRCRAFT

Glen S. Campbell, R.T.C. Lahey

NAE-AN-7

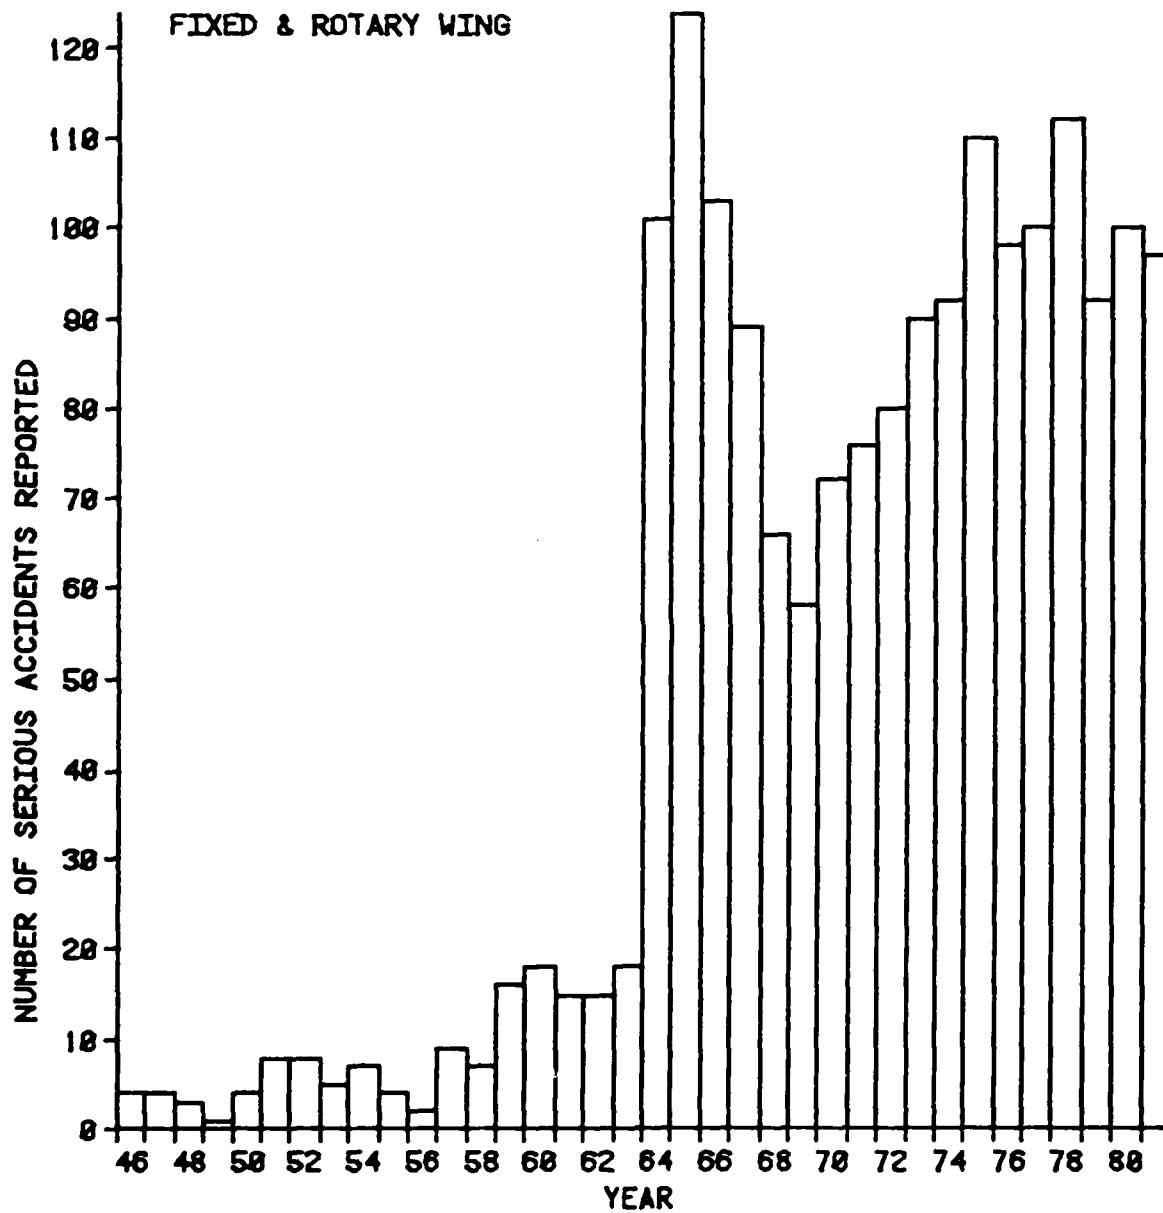
FIG. 1 NUMBER OF SERIOUS FATIGUE ACCIDENTS  
- FIXED-WING & ROTARY-WING

The total number of reported fixed-wing plus rotary-wing accidents occurring in each year is plotted in Figure 1. The big increase in the mid-1960s is the result of improved availability of accident information with the introduction of computer-based information systems in a number of countries (particularly the introduction of the US National Transportation Safety Board system in 1964). Over the last five years there has been an average of 100 fatal accidents (fixed-wing plus rotary-wing) per year resulting from metal fatigue.

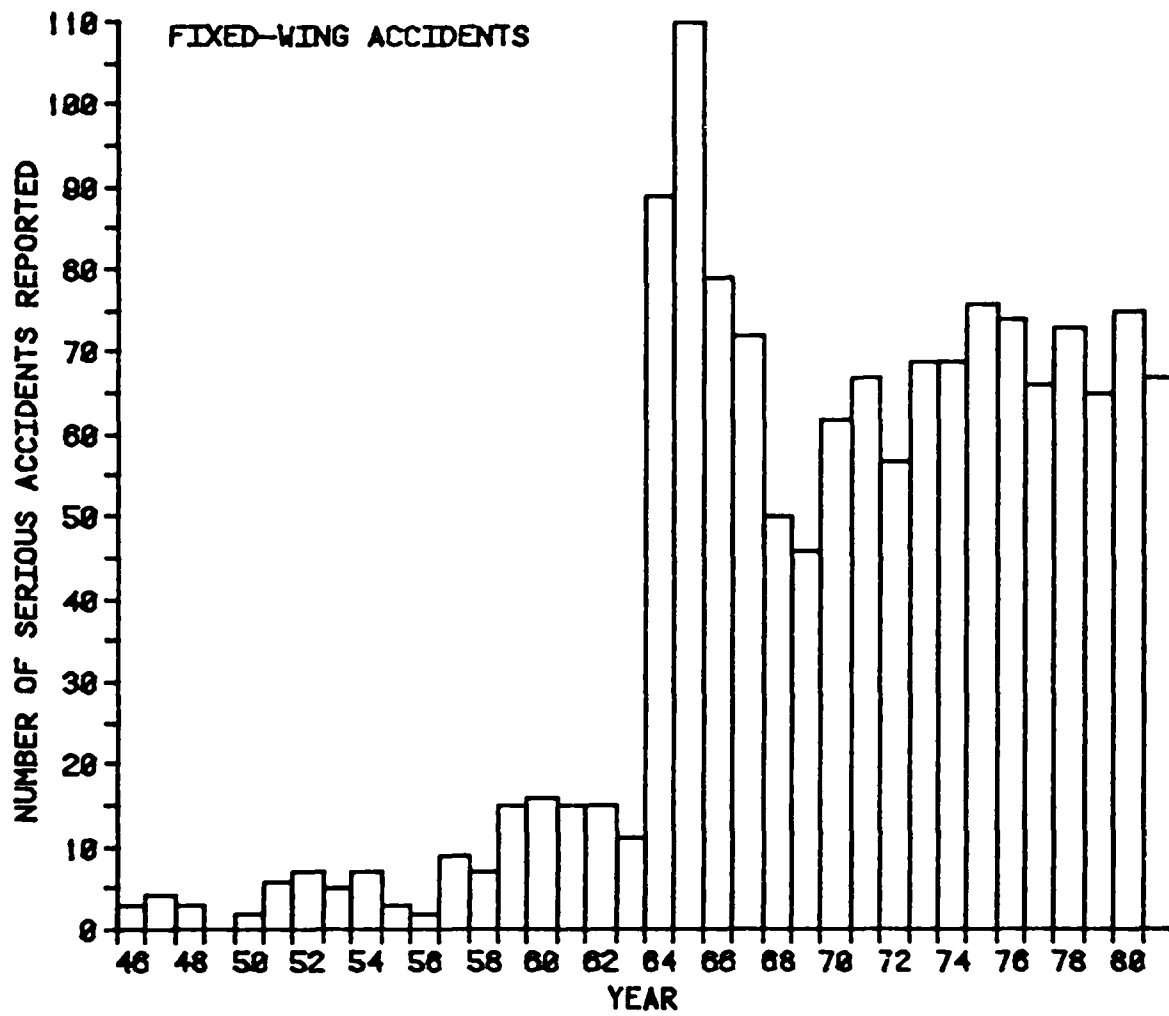
FIG. 2 NUMBER OF SERIOUS AIRCRAFT ACCIDENTS  
- FIXED-WING

The number of fixed-wing accidents for each year is plotted in Figure 2. An average of 69 serious fatigue accidents per year have occurred over the past five years. The numbers of rotary-wing accidents are shown in Figure 3.

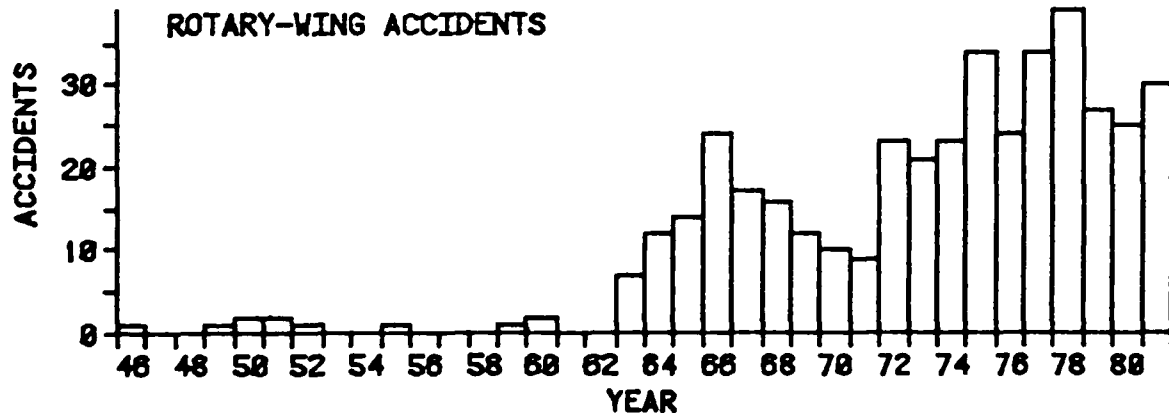
FIG. 3 NUMBER OF SERIOUS AIRCRAFT ACCIDENTS  
- ROTARY-WING
